## **Downstream Seepage Detection using Temperature Measurements and Visual Inspection – Monitoring Experiences from Røsvatn Field Test Dam and Large Embankment Dams in Sweden.**

SAM JOHANSSON      HydroResearch Sam Johansson AB  
sam.johansson@hydroresearch.se

PONTUS SJÖDAHL      Lund University  
pontus.sjodahl@tg.lth.se

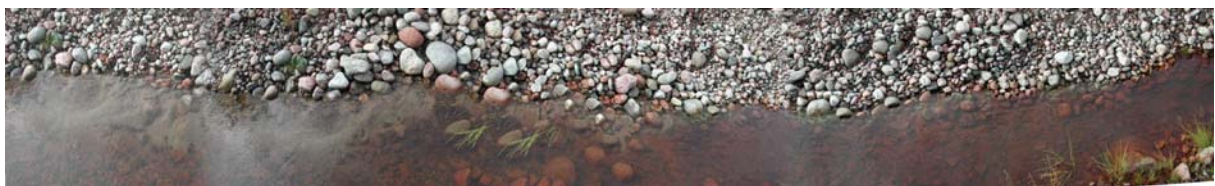
Figure 1 Concentrated outflow of muddy water and fines into a downstream ditch parallel to the dam.

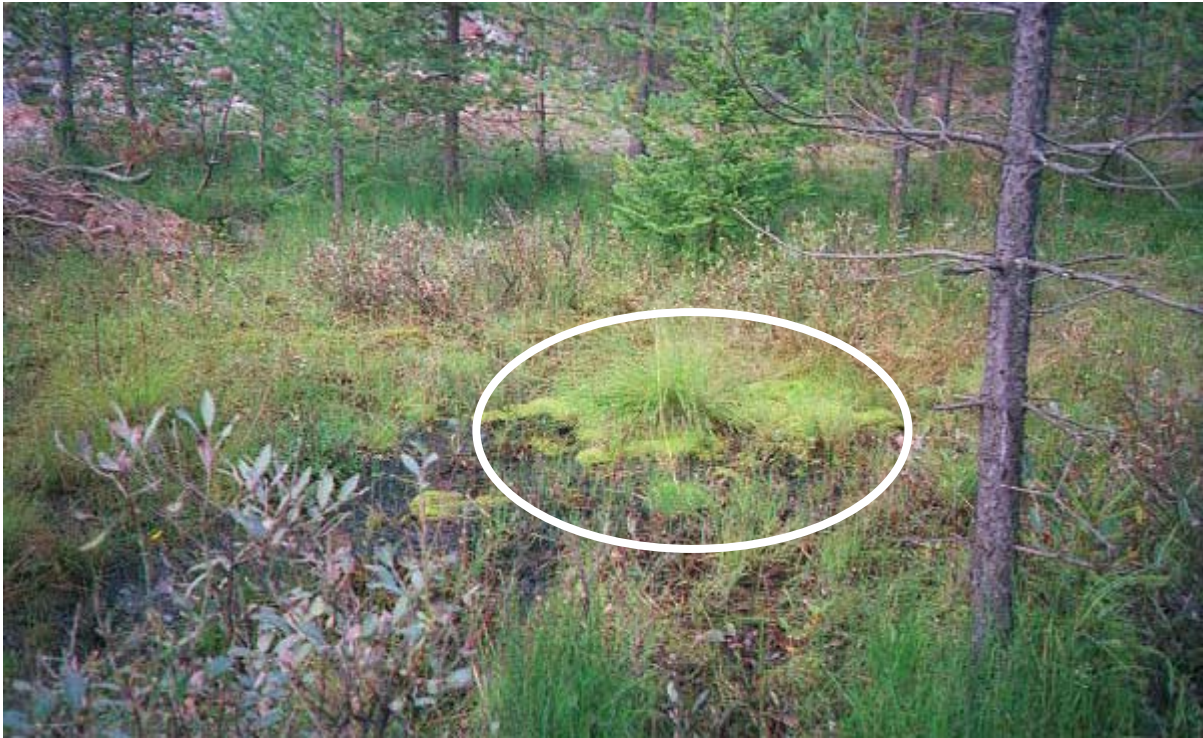
Figure 2 Light green vegetation indicating a seepage outflow area (within the white line).

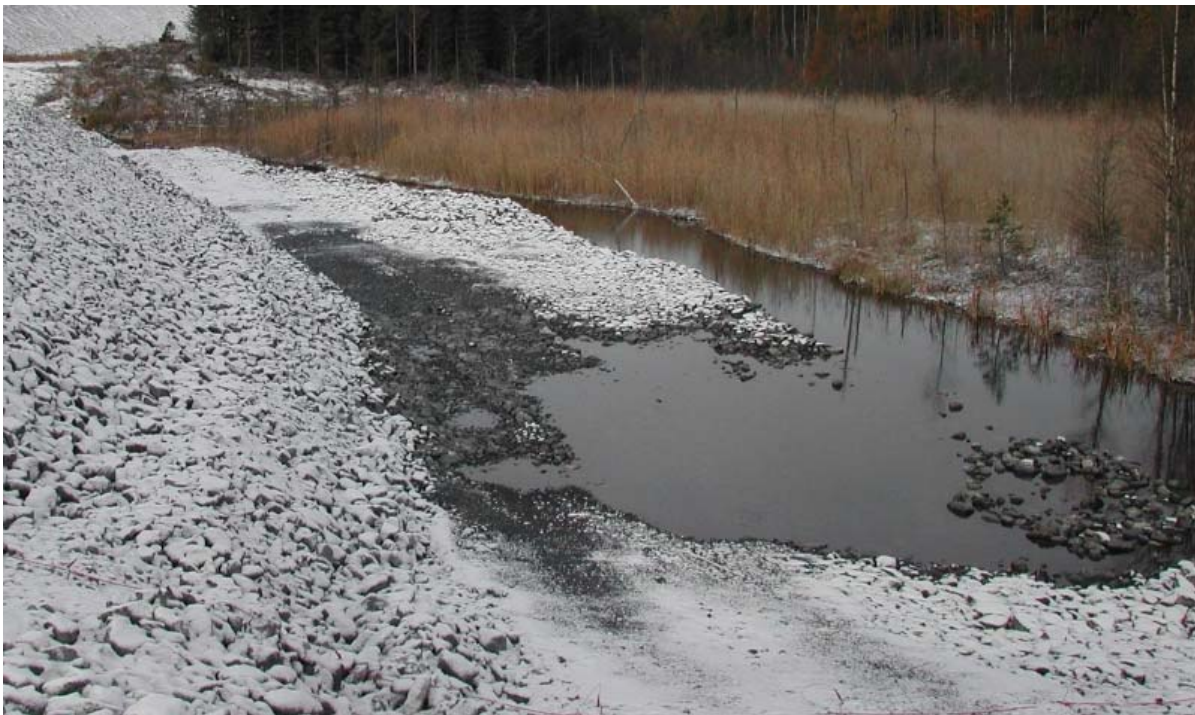
Figure 3 Seepage outflow area indicated by areas where the snow has melted.

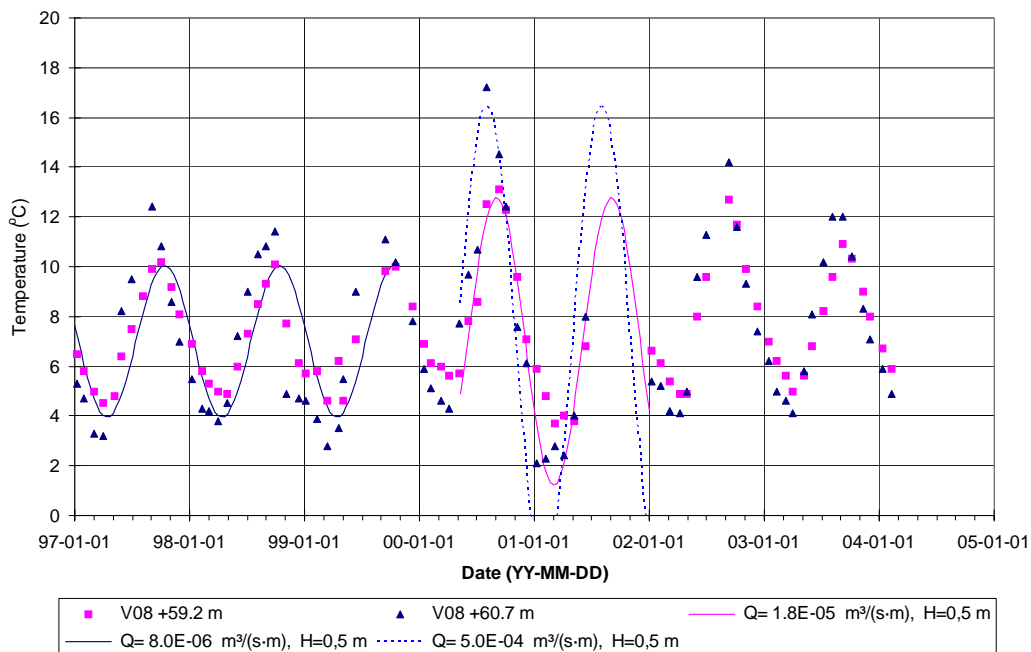
An instructive example of sudden seepage increase was observed in observation well V08 in year 2000. After 13 years with a constant seasonal temperature variation between 4 and 11°C, the maximum temperature increased to 17°C, and the minimum temperature decreased to about 2°C. The only explanation for this was a seepage increase. A sinkhole was also observed close to this area in 2002. Seepage calculations with DamTemp indicated a seepage increase from about  $8 \cdot 10^{-6} \text{ m}^3/(\text{s},\text{m})$  to about  $1.8 \cdot 10^{-5} \text{ m}^3/(\text{s},\text{m})$  at elevation +59.2m and about  $5 \cdot 10^{-4} \text{ m}^3/(\text{s},\text{m})$  at elevation +60.7m, i.e. a seepage increase of about 2-60 times. For the following three years a decreasing seasonal temperature variation is observed, indicating a decreasing seepage. The seepage decrease may depend on a self healing process. It may also be a reason for a small sinkhole that was observed in autumn 2003.

Figure 7 Measured and calculated temperature at observation well V08 at two levels.

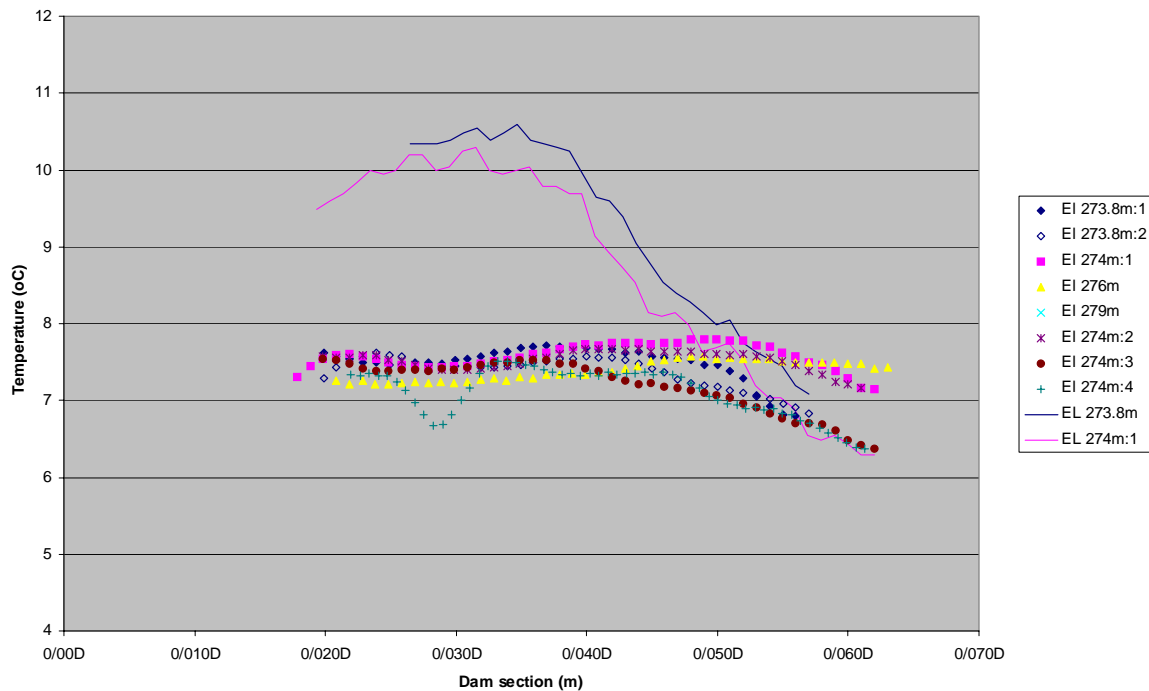
The temperature at all elevations below El. 276m shows a lower temperature around section 0/028m and at the end of the monitored part of the dam (from section 0/050 to 0/062m). All these locations are surely in the saturated part, except El. 276 that may be slightly above the water table. The lowest temperature is at the most downstream cable at El 274 (cf. El 274:4 in Figure 11) in both these areas. No signs of concentrated seepage is seen at the core (constant temperature along cable El. 274:1-3, El. 276), which indicates that the main seepage passes through the foundation.

The seepage flow cannot be estimated directly from these data. However, the temperature at section 0/028m is similar to that at section 0/060, and the seepage at those sections may therefore also be similar. Seepage evaluations from the temperatures measured in the sensors are regularly made on by Graninge/Sydskraft. Evaluations of the temperature in the vibrating sensor 60:1 indicate a seepage flow about 20-30 ml/(s,m). The length of seepage flow area can be estimated to about 2m, giving a total

flow about 0.05 l/s. This seepage flow is harmless for the dam. The total flow at section 0/060 may have an extension of 15-20m, which gives a total seepage flow of 0.5l/s, which also is a harmless flow.

Figure 11 Temperature in the estimated saturated part of the dam at El 273.8m to 276m in 1999 (solid lines) and in 2004 (point markers). Measurements indicate concentrated seepage at 0/028, and between 0/045 and 0/060m.

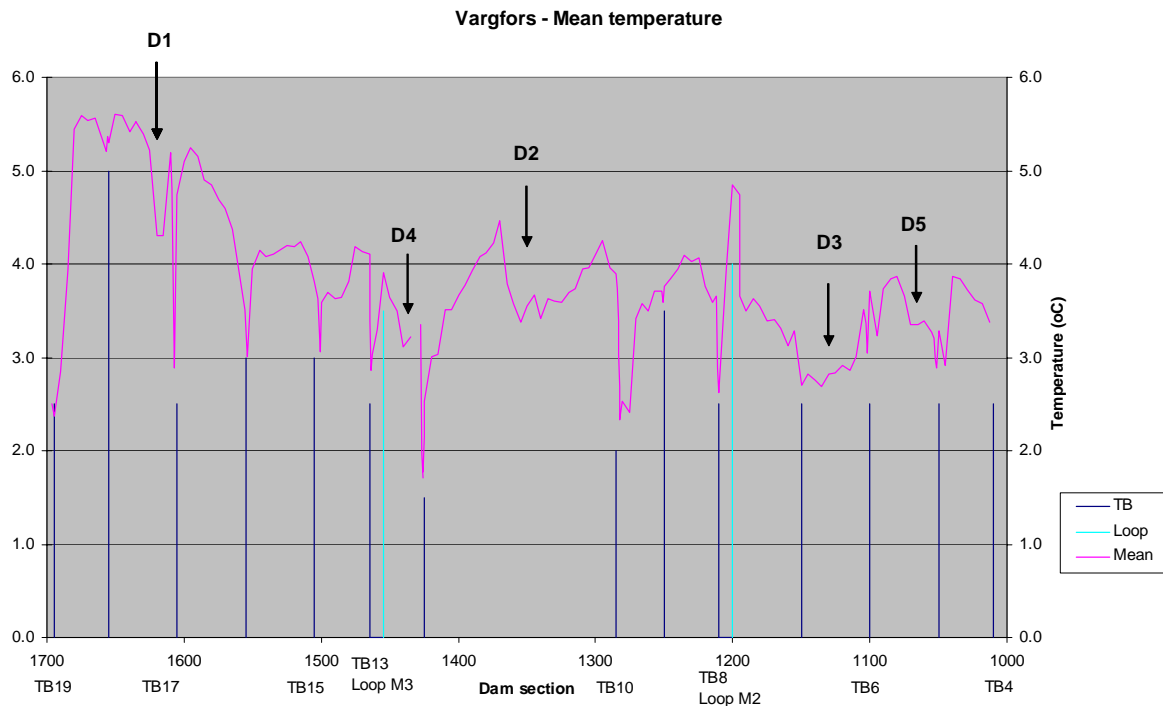
The temperature along the dam is showed in section Figure 13). The result shows generally normal seepage conditions with a few possible seepage concentrations. The most significant ones are at section 1615-1620 (D1), and at section 1/120-1/140 (D3). The other ones are smaller and more uncertain, based on this first short measurement. Further measurements are needed to verify and evaluated those anomalies.

The temperature dips that coincide with the TBs are not caused by seepage. The reason is that the upstream drain gives a shorter travel length for the seepage water, compared to its travel length to the dam toe. Therefore, a faster temperature response of the decreasing temperature in the river is seen.

Figure 13 Temperature on each 5m along the dam section.

The first dip (D1) at section 1/615-1/620, is distinct and exhibits about 1°C lower temperature than adjacent parts. This might be a sign of some higher seepage than in the other parts of the dam. The general temperature in the dam (between 3-4°C) indicates normal seepage conditions, and the small deviation at D1 will not affect the safety of the dam.

The two last dips (D4 and D5) are concentrated but smaller and more uncertain. Also some other areas could be mentioned as possible seepage areas.

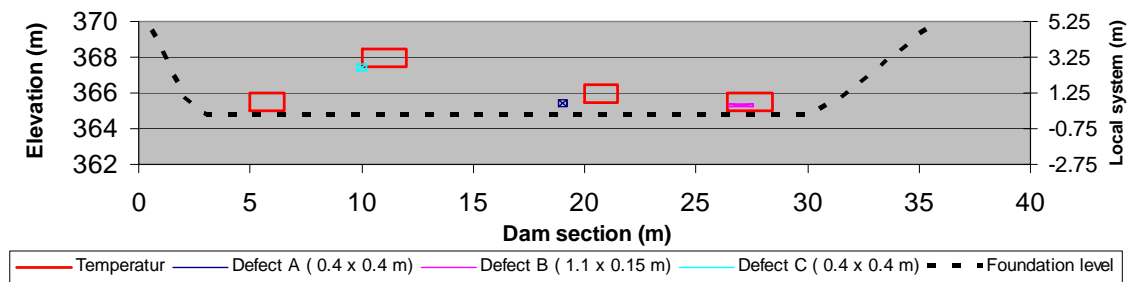
These detected leakages areas agrees well with the real ones (Figure 19). Another leakage area was also detected close to the drainage pipes. The elevation in the figure is set to the inflow level  $\pm 0.5\text{m}$ . Temperature measurements at the dam toe can normally not exactly determine the level of a defect, just the location along the dam. In this case, however, information from the different fillings could be used to estimate also the level.

Figure 19 Defect location and defect areas evaluated from temperature measurements. Note that the level is estimated only from the water level in the reservoir.

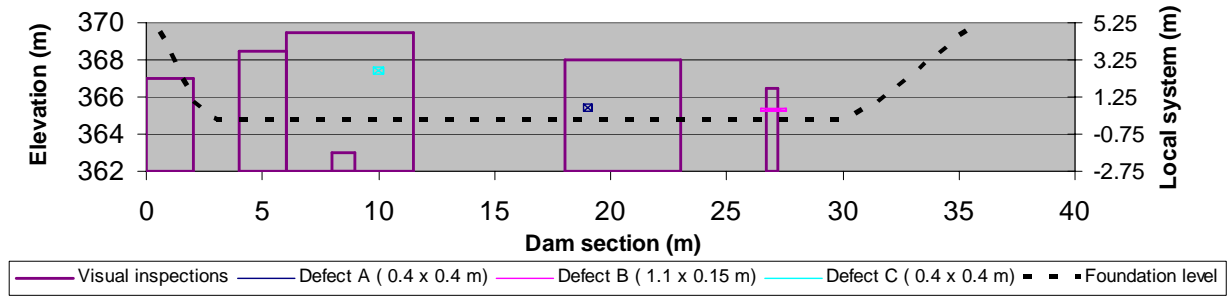
The result can be compared with the real locations as done in Figure 20. It is difficult to define the level from the water level information, so the inflow level is chosen as the highest possible level. The lowest level is chosen constant, equal to the lowest observed outflow level. Visual inspections will in this case detect all three defects. The seepage outflow areas are much wider than the defect, but will still give some indications where the defects are located.

Figure 20 Defect location and defect areas evaluated from visual inspection of the dam toe. Note that the upper level of the defects is estimated only from the water level in the reservoir, and the lowest level is shown as the lowest level of the observed outflow at the dam toe.
