Structural Monitoring in Railway Infrastructure

Dynamic Integrity Monitoring for Rail Infrastructure Using Distributed Fibre Optic Strain Sensors

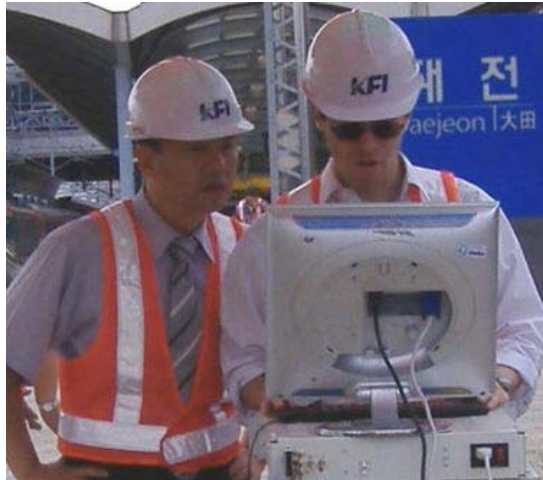
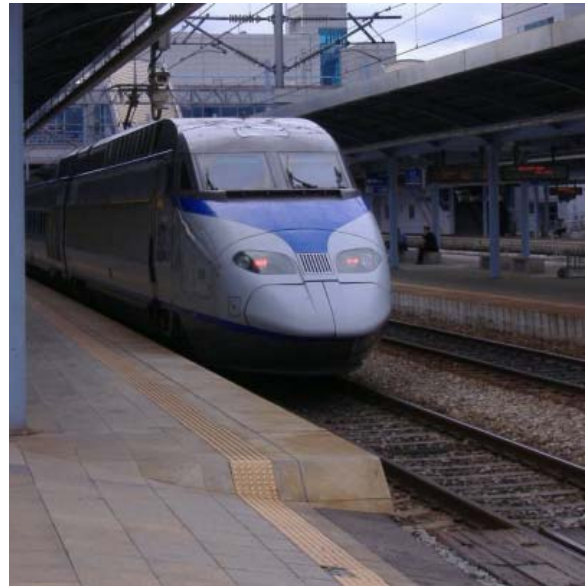
The aim was to analyse the integrity of a section of track that had recently been repaired. The Sensornet Distributed Temperature and Strain Sensor (DTSS) was used to monitor this 60m section of track while a KTX train passed over.

The DTSS is optimised for single-ended measurements, needing access to just one end of the installed cable. Sensornet's revolutionary approach replaces the need for multiple point sensors with one distributed sensing cable, reducing design, installation & instrumentation costs and greatly improving the amount of information obtained.

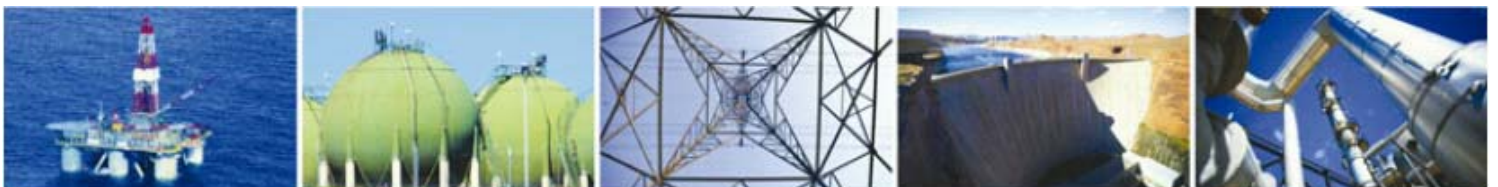
During 2005, Sensornet introduced a new innovation to the DTSS, for the first time achieving fast (dynamic), fully distributed measurements of strain. The instrument can now measure strain at acquisition rates of up to 10Hz (ten times a second), allowing detection of rapid deformations or movements in structures.

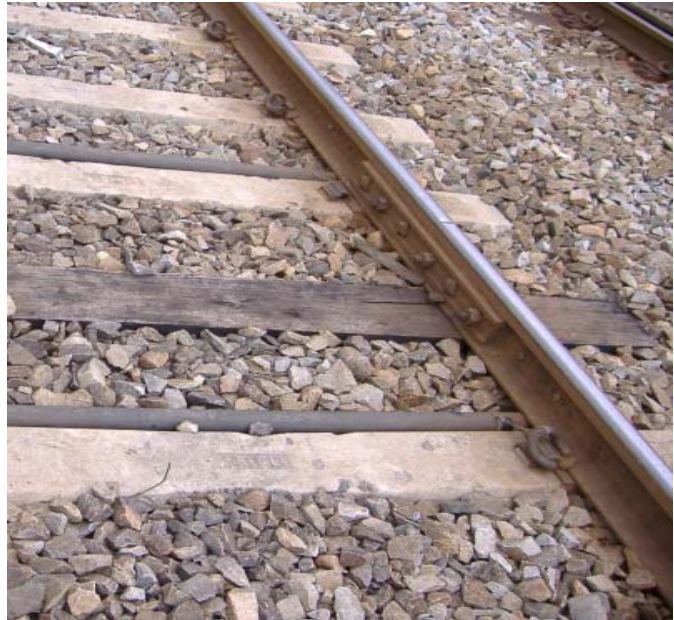
Bonding of Sensor cable to Rail

For this trial the DTSS sensing cable was bonded to the flange of the rail, close to the intersection with the lowest part of the web. This position was chosen for ease of installation and higher sensitivity to flexural movements. The sensing cable was installed as a temporary trial and so un-armoured fibre optic cable with an OD of 1mm was used. For longer term installations, Sensornet can supply a range of cables which provide greater protection to the fibre, while still transmitting the strain from the monitored structure to the fibre inside.

The cable was bonded to the rail along a 60 m section of the track, close to the platform at Daejeon. Towards the far end of the 60m section the fibre crossed over a section of track which had been previously repaired. An expansion joint was inserted here to alleviate problems arising from expansion during the winter and summer months. Additionally, one of the concrete sleepers was replaced with a wooden sleeper and so overall, greater flexing of the rail was expected in the region of this expansion joint.

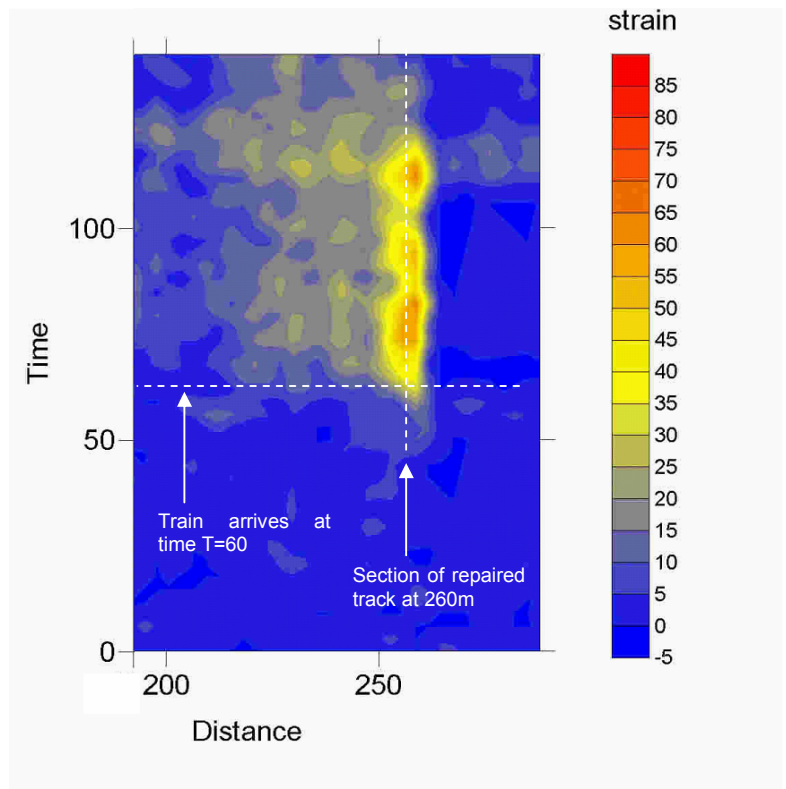
The dynamic strain data was captured by the DTSS and converted into a 2-dimensional colour map to visualize the changes in strain.

The distance along the sensing cable is shown along the X-axis and time along the Y-axis, while the intensity of strain is visualized according to colour varying from blue (0 microstrain) to red (equaling 90 microstrain). Note, that the DTSS was situated at a distance from the track and so there was a communication lead of 190m between the DTSS and the monitored section. The section that had been repaired is located at 260m along the length of the sensing cable. The colour map indicates the change in strain of the rail relative, to a period of time just before the train arrived when there was no changing strain in the rail. This is done to remove any long term variations in strain resulting from installation of the fibre, which is quite normal.

As can be seen from the chart from time T=0 to T=60 seconds, the strain along the monitored section of rail is very small, in the range of 0-10 microstrain. Once the train arrives there is a substantial increase of strain in the rail when the train passes over it. In the repaired section the strain increases to levels of 90 microstrain, whereas in the section of regular track the strain is in the region of 30-50 microstrain.

The theoretical calculation, whilst based on several broad approximations, yields an expected strain value of 100 microstrain, in excellent agreement with the DTSS.
