## **Downstream Seepage Detection using Temperature Measurements and Visual Inspection – Monitoring Experiences from Røsvatn Field Test Dam and Large Embankment Dams in Sweden.**

SAM JOHANSSON      HydroResearch Sam Johansson AB  
sam.johansson@hydroresearch.se

PONTUS SJÖDAHL      Lund University  
pontus.sjodahl@tg.lth.se

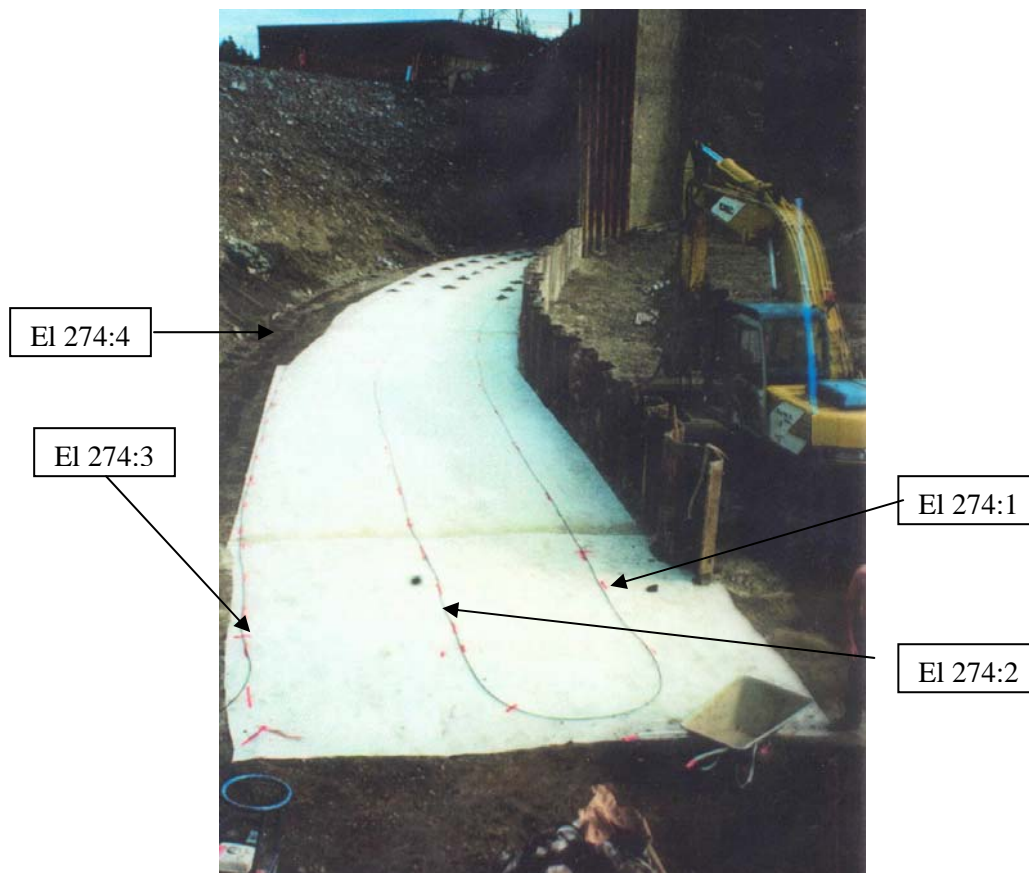
During the summer of 1998 the upper part of the dam was excavated down to elevation +272 along an 80m length from the intake structure (section 0/018) to about section 0/100). The excavation was carefully documented and several examples of internal erosion were found due to improper downstream filter and construction errors. From excavation level and down to the bedrock, a diaphragm wall was constructed in the old core and down to the bedrock. A sheet pile was pushed in the slurry down to the bedrock. Additional drilling and grouting was carried out in the bedrock in order to obtain a proper sealing between the diaphragm wall/sheet pile and the bedrock. The diaphragm wall ends at section 0/058.

Figure 9 Geomembrane connected to the sheet pile at El +274.0. Two fibre-optic cable loops can also be seen on the top of the geomembrane and on the downstream filter. (Photography by Graninge AB).

A new core of moraine replaced the excavated part of the dam with proper downstream filters. The core, which was placed on a filter layer with a geomembrane on top, that was sealed towards the sheet pile, see Figure 9.

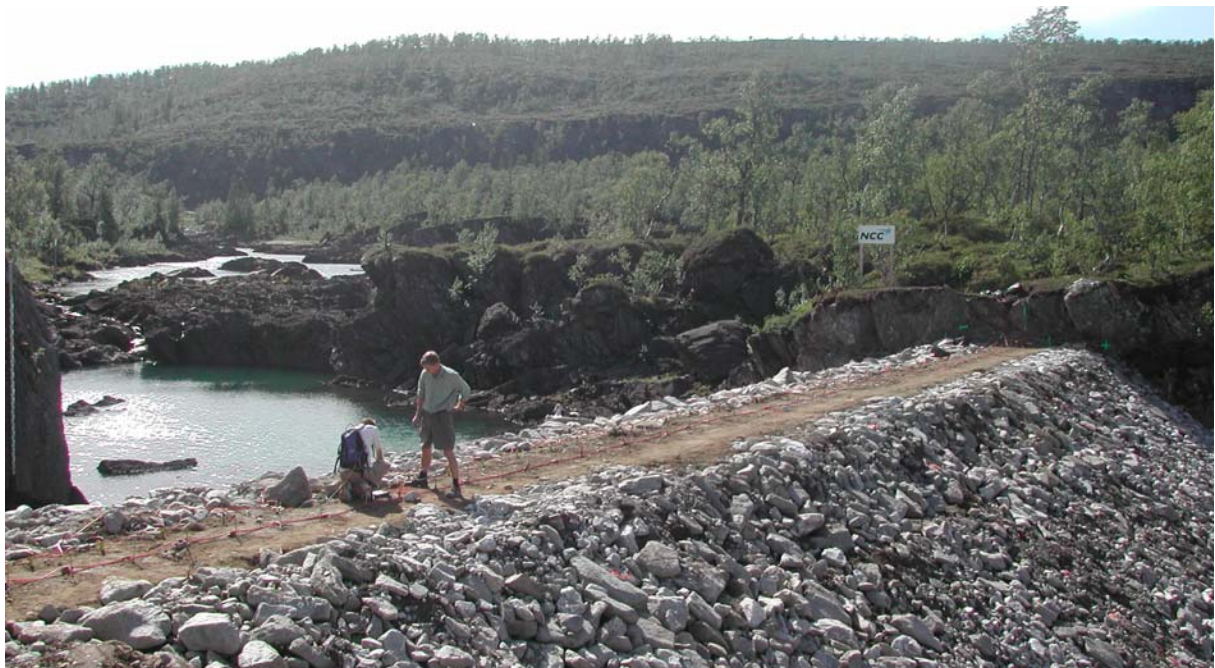
Figure 14 Downstream view of the dam at low reservoir level.

All leakage water is intended to be caught in a weir at the left abutment. The weir was built in into a concrete bar located downstream the dam toe. Manual measurements were made regularly during the tests. The visual inspections showed that water was passing under the bar on the left side. The leakage flow showed in Figure 2 is thus not the total flow through the dam.

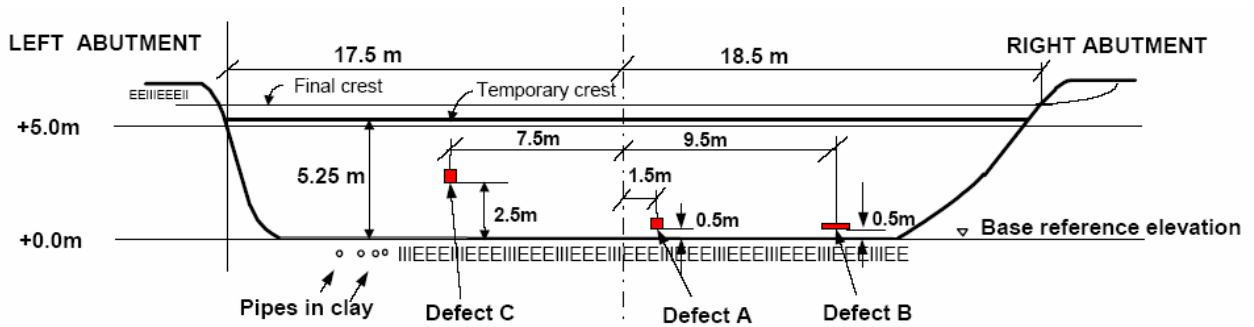
Three defects were constructed in the dam as shown in Figure 16. Information of their size, location and material properties was released long after the final report was given. The material in the all defects was sand. The sizes of the defects were: Defect A - 0.4x0.4m, Defect B - 0.15x1.1m, and Defect C - 0.4x0.4m.

Figure 16 Location of the defects; Defect A at chainage 19m, Defect B at chainage 27m, and Defect C at chainage 10m.

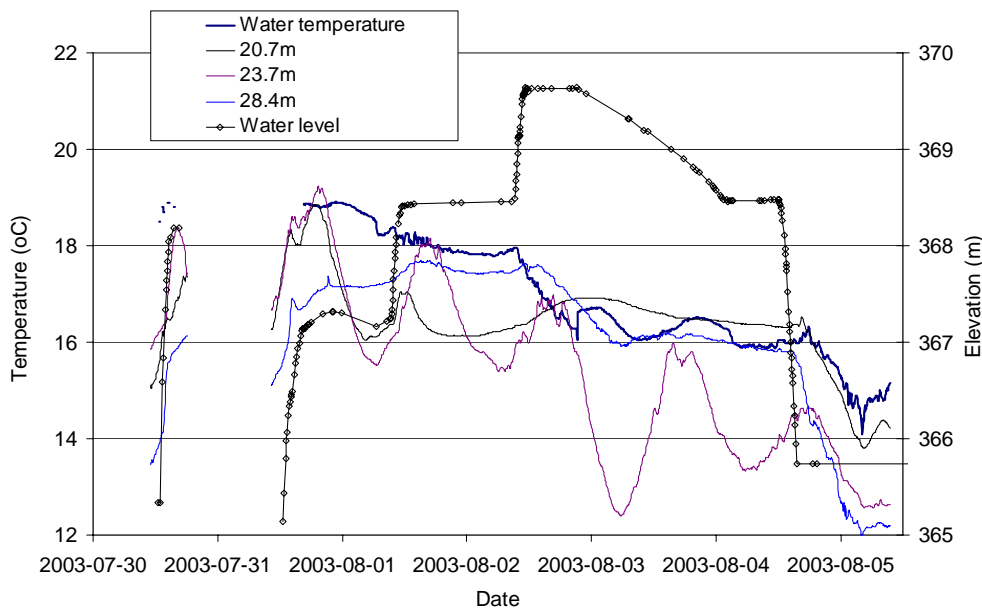
Some results are presented in Figure 3. At section 23.7m diurnal variations occur during the entire test period. This indicates that the heat conduction dominates, i.e. a low seepage. The effect of a significant seepage is shown at section 28.4m. The diurnal variation is seen both at Filling #1 and #2, until the temperature rise is interrupted, due to the outflow of seepage water. The temperature is then slowly approaching the temperature in the reservoir. The same is seen in section 20.7m at the Filling#3. Significant seepage outflow areas were found in four areas from the temperatures showed in Figure 17 and Figure 18.

Figure 17 Selected temperature measurements between section 20m and 30m (left axis), and reservoir water level (right axis).

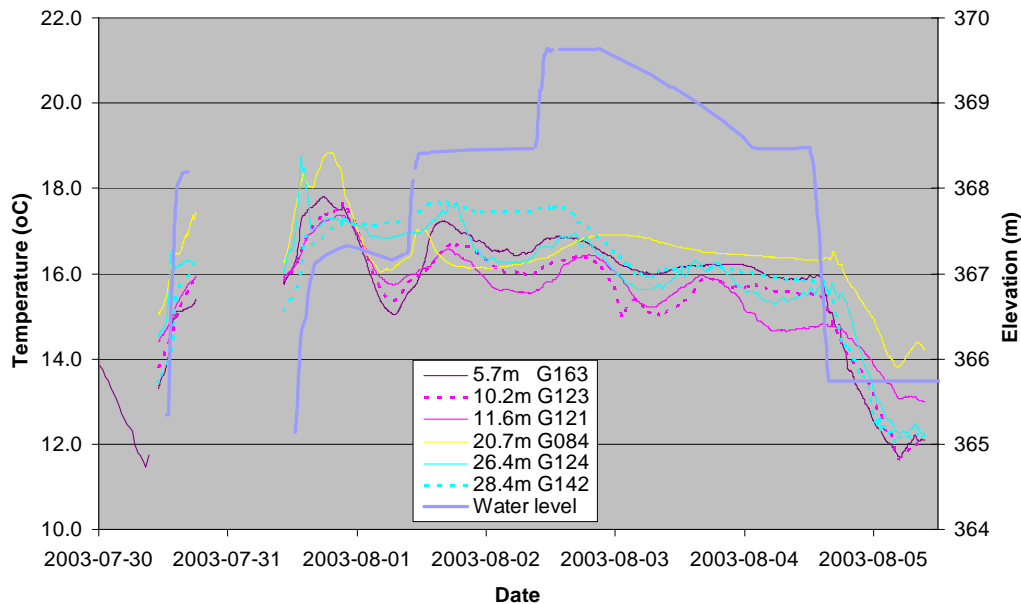
The data were analysed further to estimate the transient temperature change due to the advective energy transport by the seepage flow. Some seepage flow estimations were also made at Filling #1-#3, indicating flows exceeding  $0.6\text{l}/(\text{s},\text{m}^2)$  at section 27, about  $0.2\text{l}/(\text{s},\text{m}^2)$  at section 20.7m, about  $0.4\text{l}/(\text{s},\text{m}^2)$  at section 5.7m, and about  $0.3\text{l}/\text{s},\text{m}^2$  at section 10.2/11.6m. The total area of the defect cannot be determined from the temperature data, so the total flow cannot be estimated.

Figure 18 Selected temperature measurements between section 20m and 30m (left axis), and reservoir water level (right axis)
